Port Neches-Groves ISD

Facility Assessment

Gallagher Construction Services
3501 Token Drive, Suite 100
Richardson, Texas 75082
(972) 633-0564

February 21, 2014

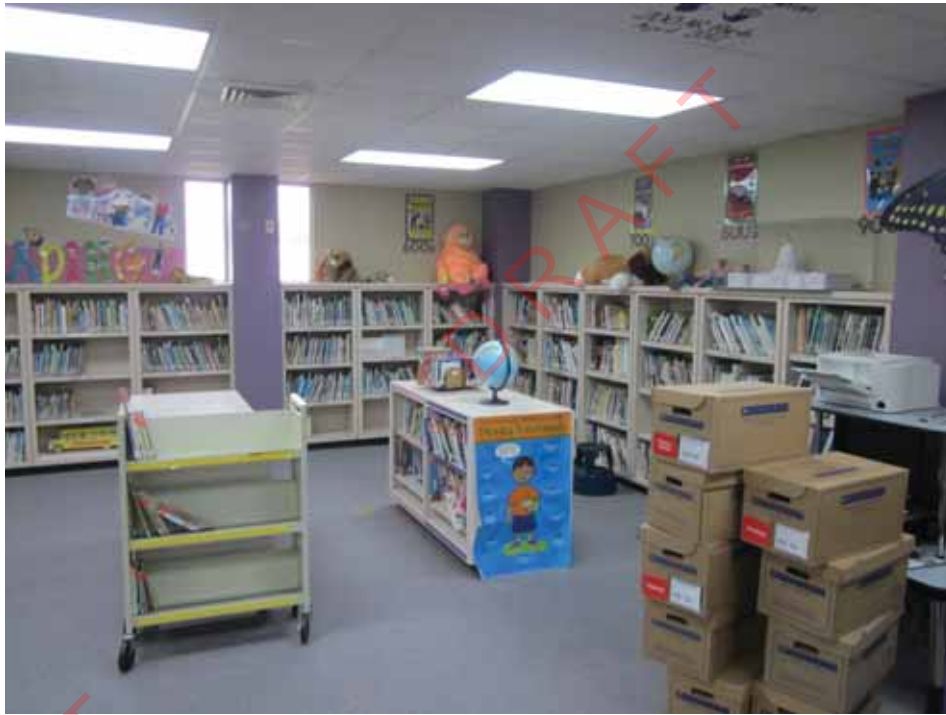
PHOTO TES1 - LIBRARY

- The current library is 1,800 square feet and **DOES NOT** meet current TEA Facilities Standards requirements for size. A minimum size of 1,400 square feet, plus 4 square feet per student is required by TEA for a facility of this size. The functional capacity of this campus of 493 students would require 3,372 square feet of Library space to meet current TEA standards. (Refer to Photo TES1)

Additional Library space should be provided to bring the campus up to current TEA standards

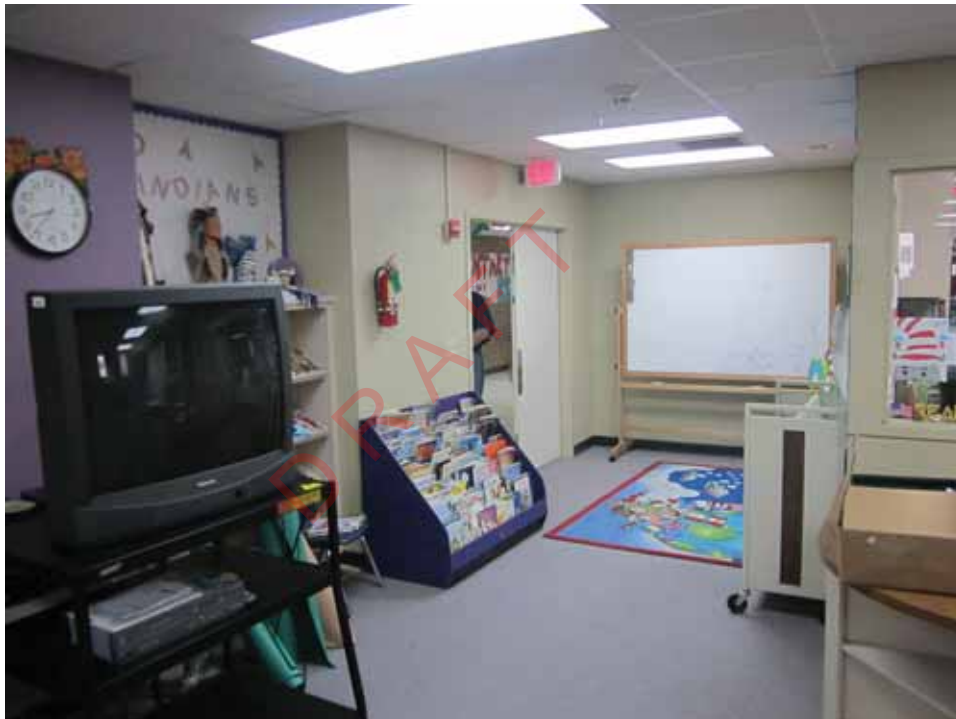
PHOTO TES2 - LIBRARY DOOR

- The library currently has only one (1) entrance/exit. Life safety code requires a secondary exit for all rooms with an occupancy exceeding 49 persons. (Refer to Photo TES2)

A secondary exit should be added to the Library.

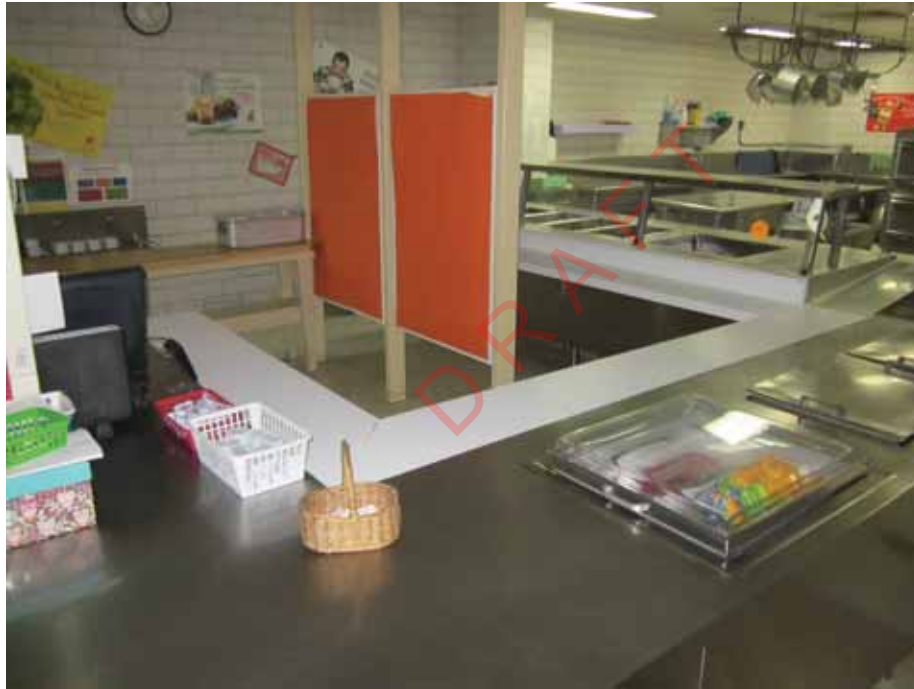
PHOTO TES3 - KITCHEN SERVING LINE

- The kitchen and cafeteria are undersized for the enrollment at this campus. The kitchen currently has only one serving line, which limits the number of students that can be served during a lunch period. (Refer to Photo TES3)

The Kitchen and Cafeteria space should be expanded to adequately serve the student population.

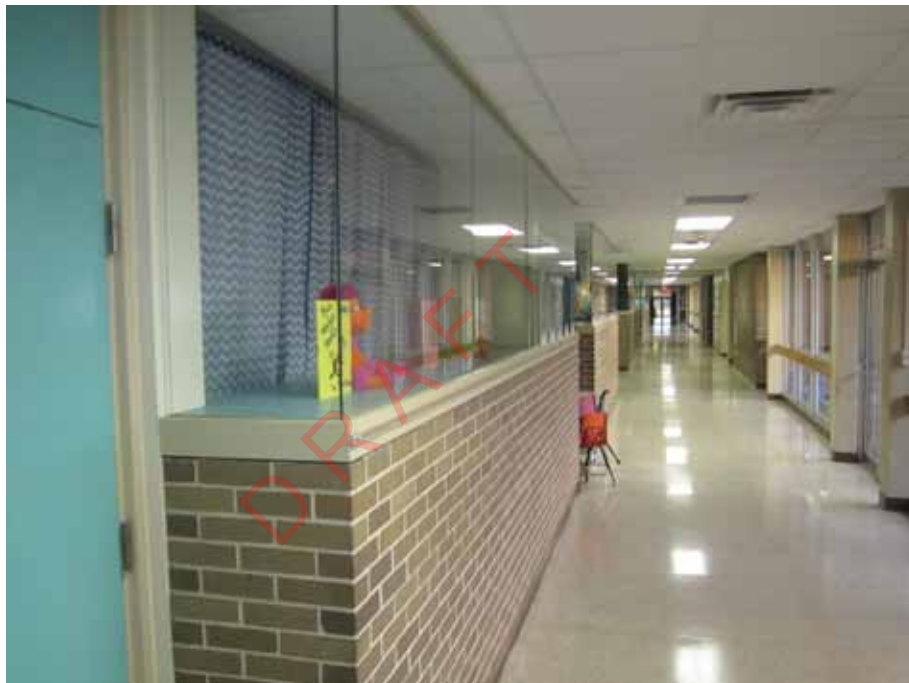
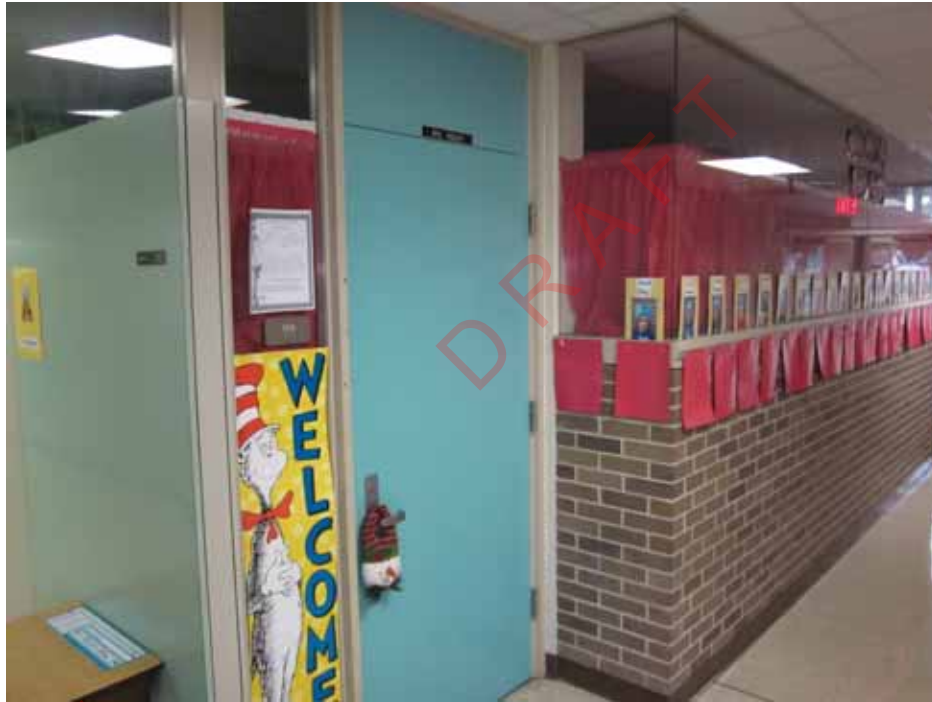
- The amount of glass in the corridors makes security within the campus very difficult. Most teachers have covered the glass to protect visual security, but the existence of the glass remains a physical security issue. (Refer to Photos TES4 and TES5)

PHOTO TES4 - CORRIDOR/CLASSROOM WALLS

PHOTO TES5 - CORRIDOR/CLASSROOM WALL AND DOOR

The glass in the corridors should be adequately addressed to improve security.

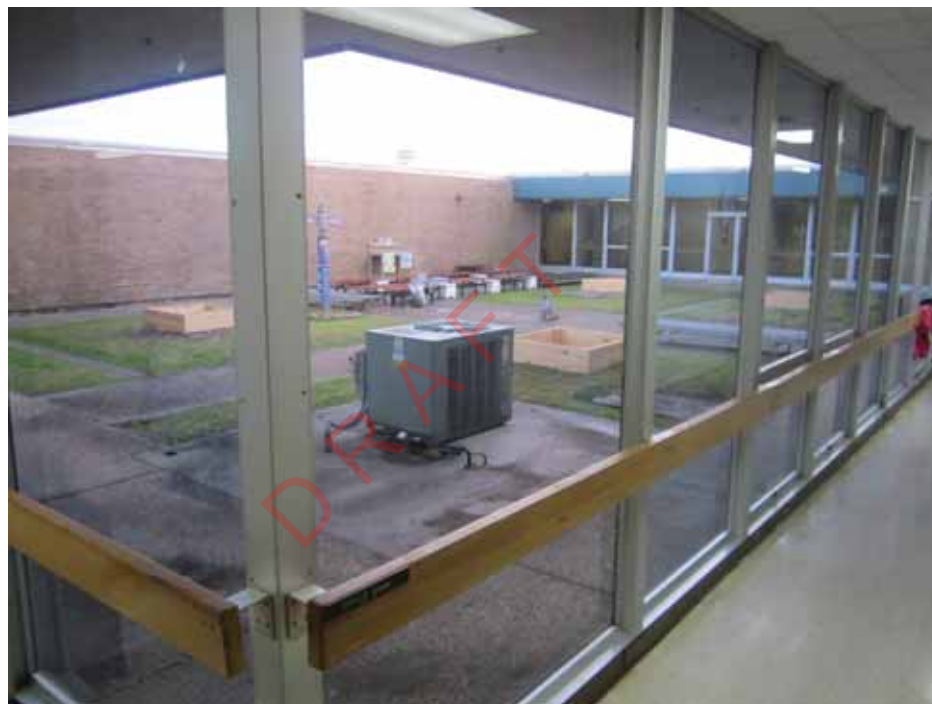
PHOTO TES6 - COURTYARD

- The two courtyards at this campus are mostly unused space and require additional staff resources to maintain. (Refer to Photo TES6)
- Due to the location of this campus, the Visual Aide Room and Gymnasium have finished floor elevations that are lower than the normal level of the nearby Sabine Lake. A floor drain and sump have been installed in the Visual Aide room to alleviate flooding during precipitation events. The moisture from this flooding could cause indoor air quality issues at this campus.

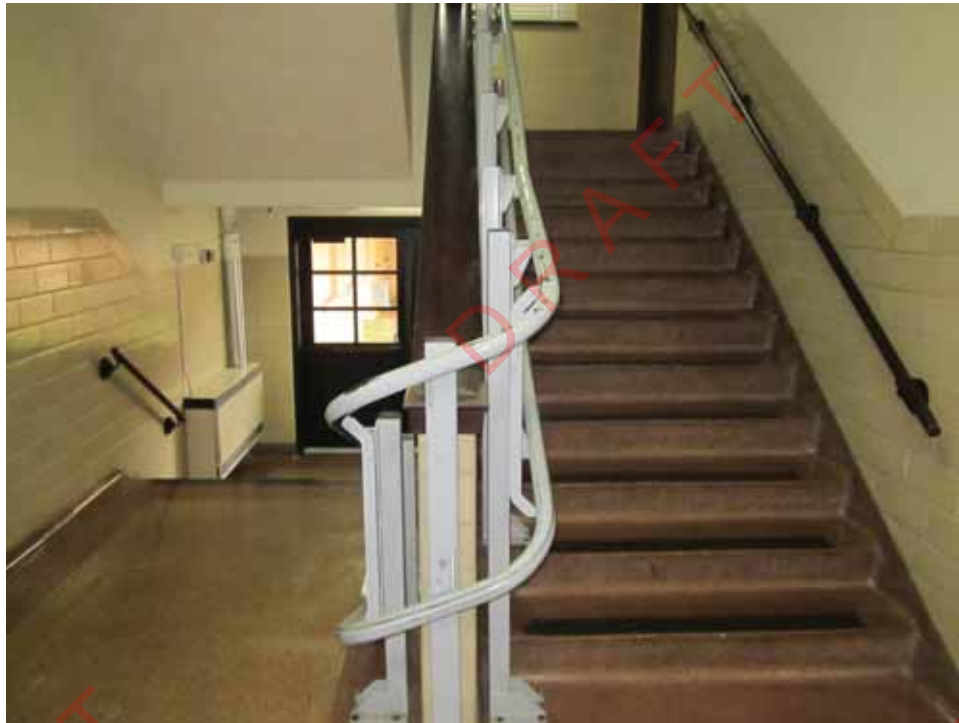
PHOTO GES1 - CHAIR LIFT

- There is currently not an elevator in the building. Access to the second floor is by chair lifts at the stairs. (Refer to Photo GES1)
- The gang restrooms in the main building do not meet current ADA standards. (Refer to Photo GES2 and GES3)

It is recommended the campus be brought up to current accessibility code standards.

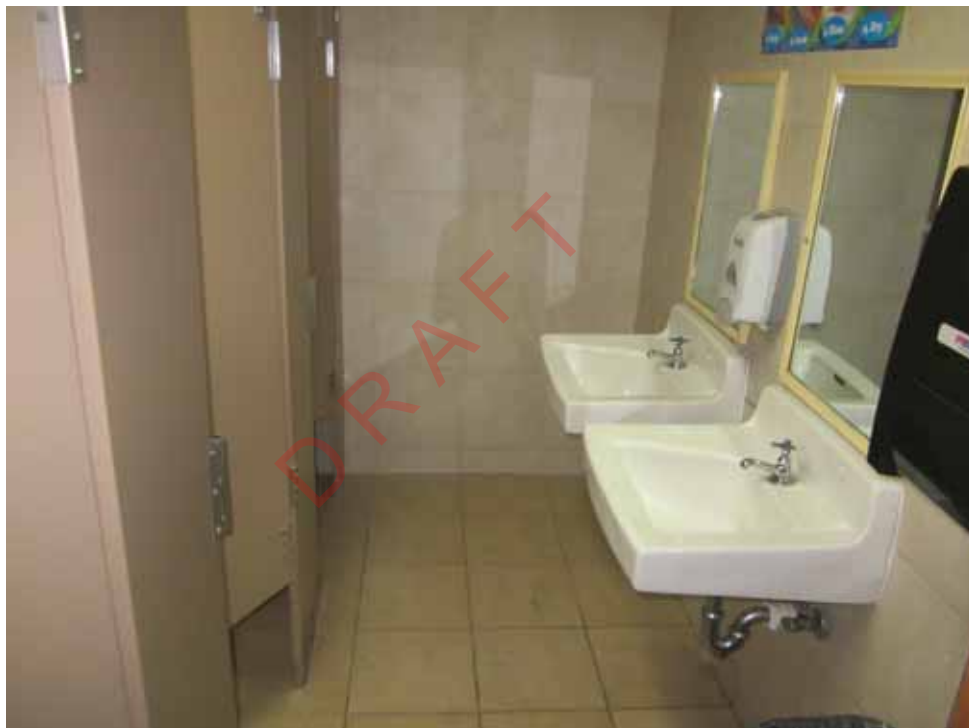
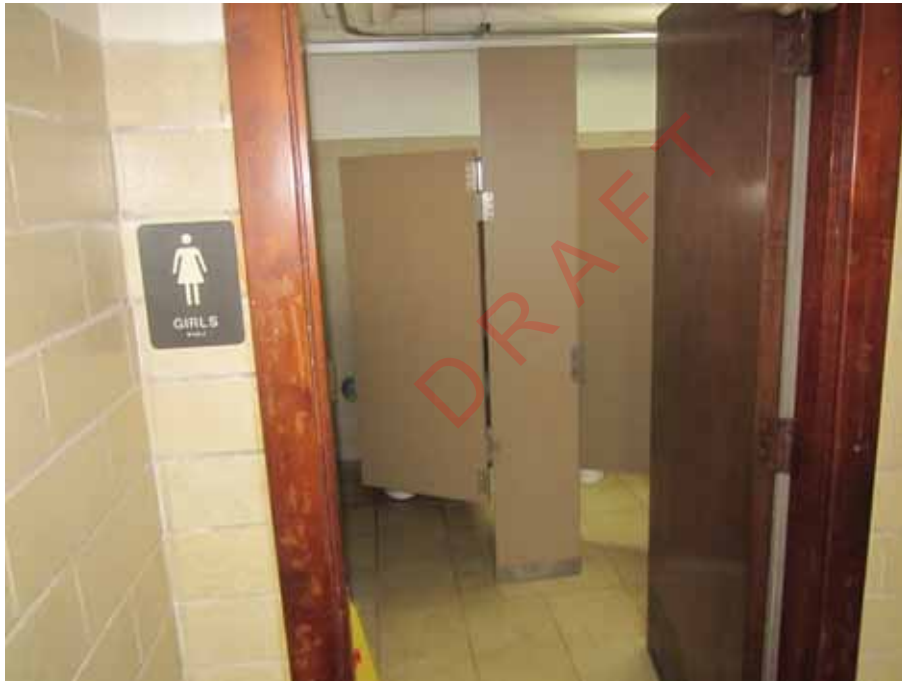
PHOTO GES2 - GANG RESTROOM

PHOTO GES3 - GANG RESTROOM

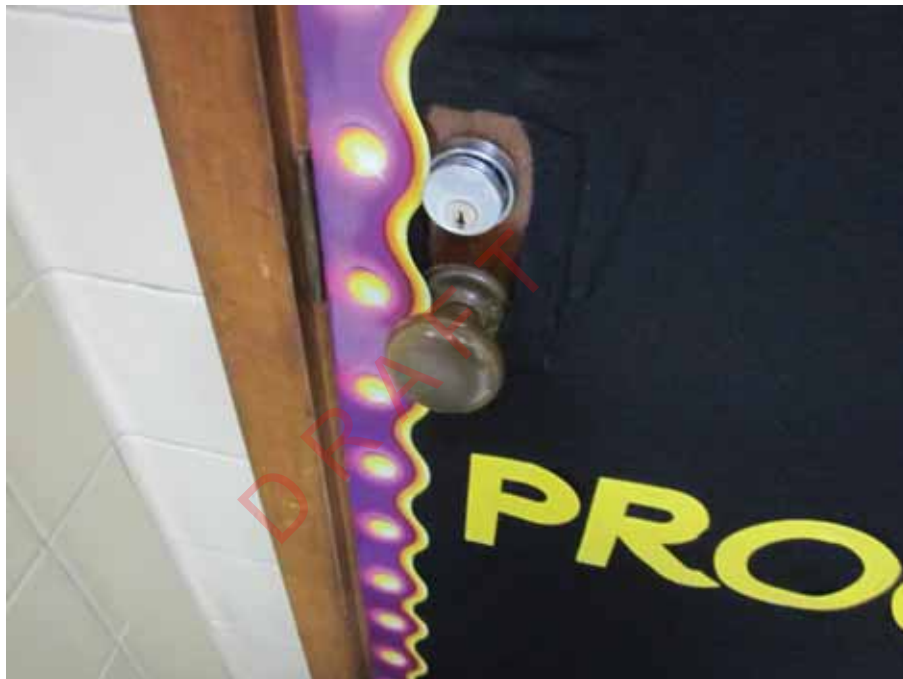
PHOTO GES4 - DOOR HARDWARE

- The door hardware in the main building does not meet current ADA standards. (Refer to Photo GES4)
- Entrances to the classrooms in the main building do not meet current ADA standards.

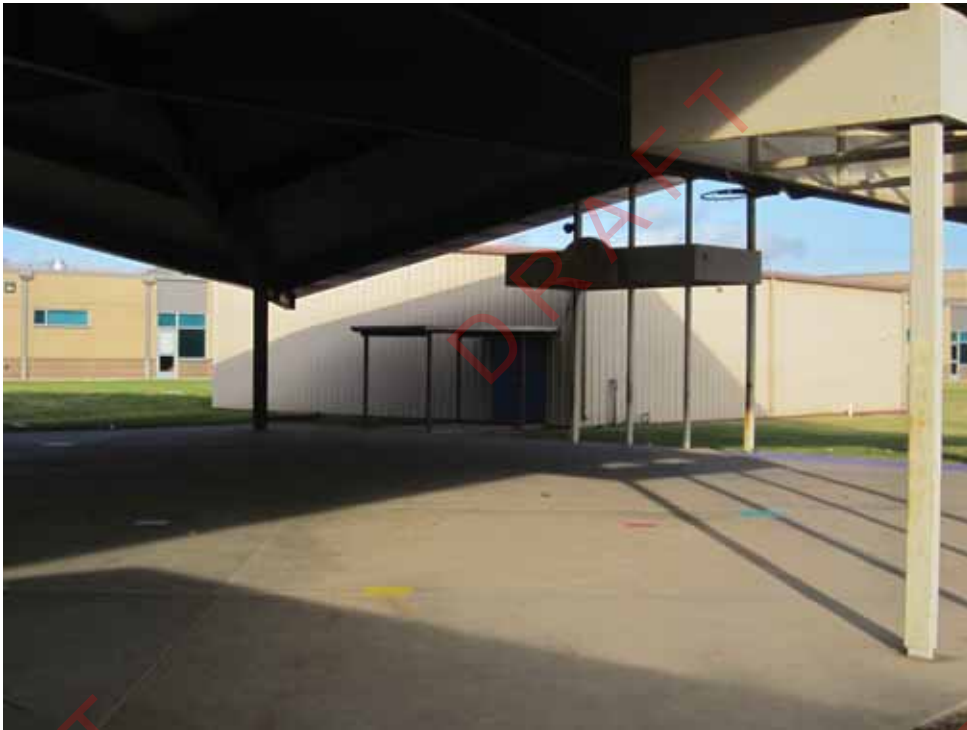
PHOTO VBES1 - GYM

- The detached Gymnasium is closer to Groves Middle School than Van Buren Elementary School. The size of the Gymnasium is not adequate for the student population at this campus. There are not adequate restroom facilities in the Gymnasium. (Refer to Photo VBES1)

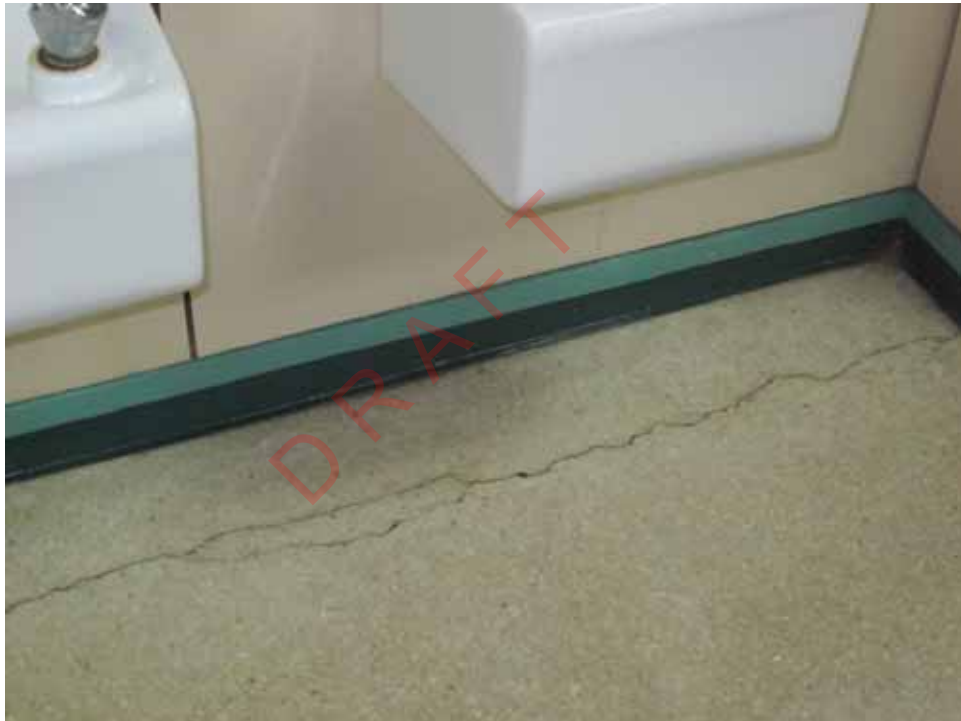
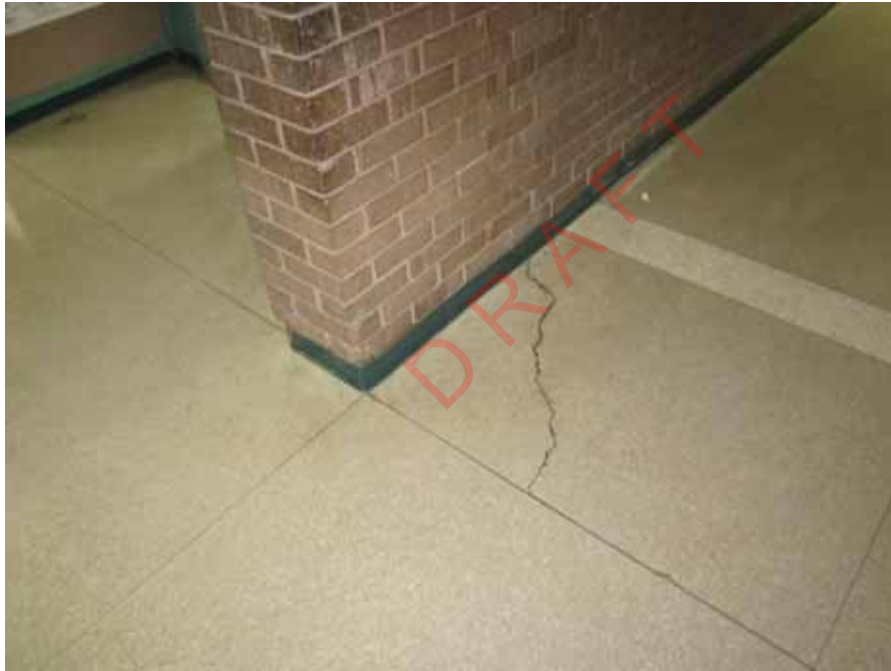
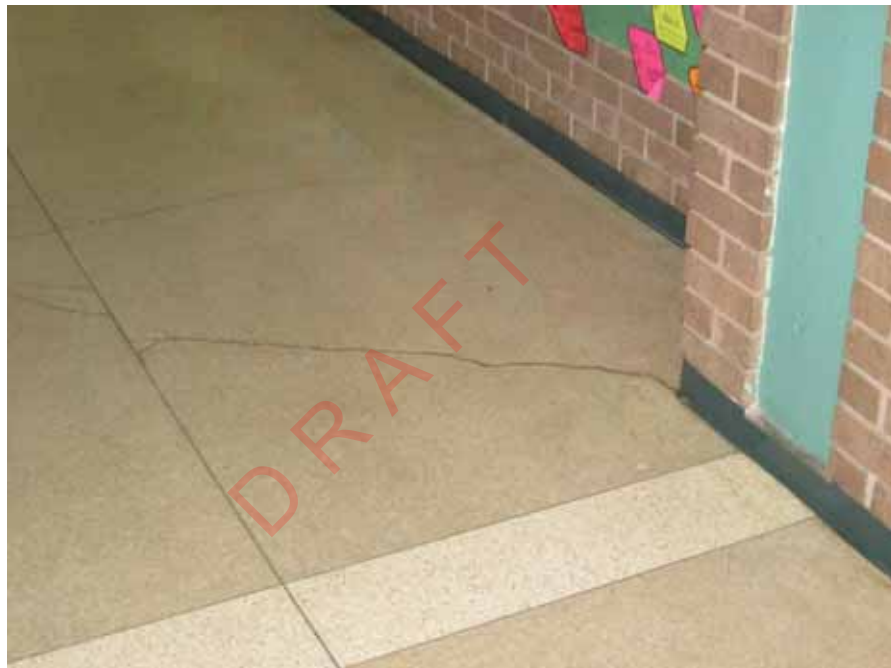
- There appear to be some potential foundation issues at this campus as evidenced by cracks in the terrazzo floors. (Refer to Photos VBES2, VBES3 and VBES4)

PHOTO VBES2 - FLOOR CRACKS

PHOTO VBES3 - FLOOR CRACKS

PHOTO VBES4 - FLOOR CRACKS

A more in-depth study should be performed by a qualified structural engineer to determine the extent of potential foundation issues.

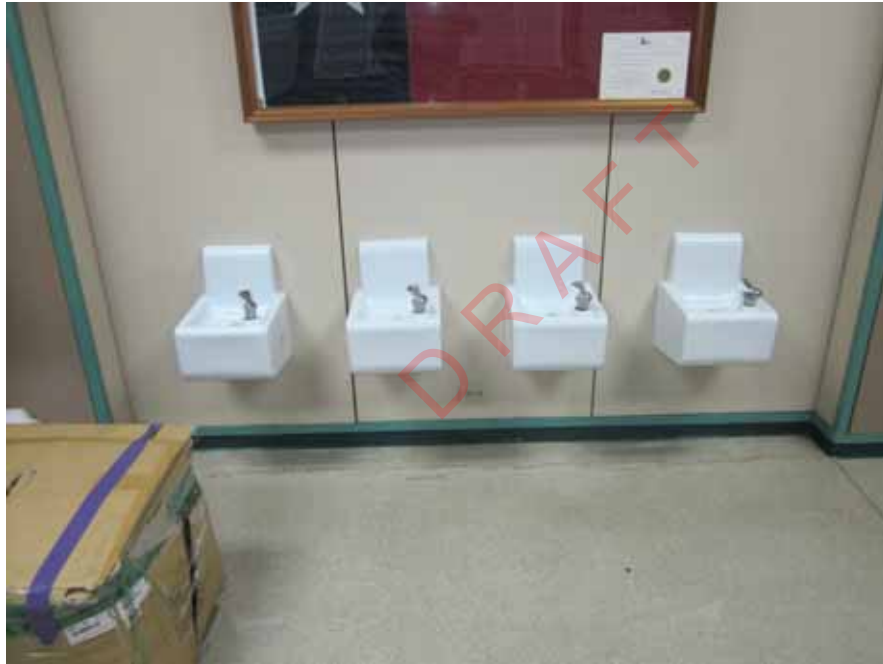
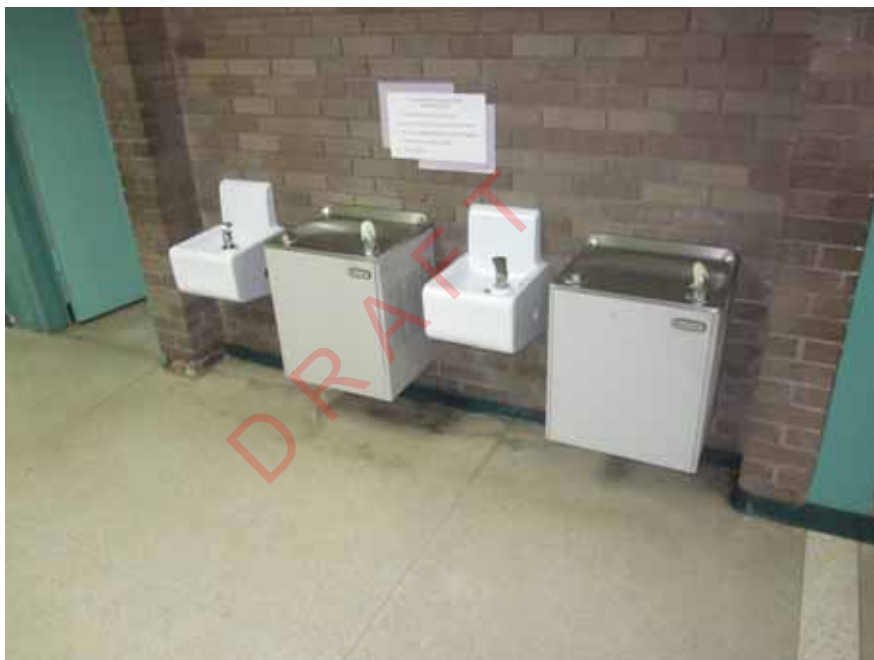
- The drinking fountains at this campus do not meet current ADA standards. (Refer to Photos VBES5 and VBES6)
- The current library is 2,200 square feet and **DOES NOT** meet current TEA Facilities Standards requirements for size. A minimum size of 1,400 square feet, plus 4 square feet per student is required by TEA for a facility of this size. The functional capacity of this campus of 405 students would require 3,020 square feet of Library space to meet current TEA standards. (Refer to Photo VBES7)

PHOTO VBES5 - DRINKING FOUNTAINS

PHOTO VBES6 - DRINKING FOUNTAINS

It is recommended the campus be brought up to current accessibility code standards.

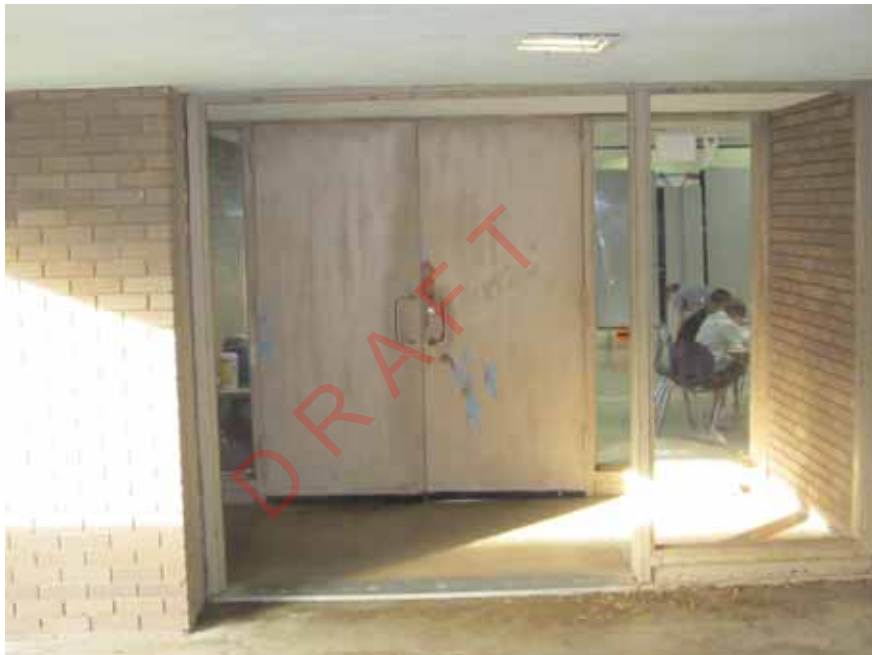
PHOTO VBES10 - HOLLOW METAL DOORS

- Exterior hollow metal frames are in need of repair and painting. (Refer to Photo VBES10)
- The bus drive and kitchen/service drive are located in the same area for this campus. This creates both traffic and safety issues.

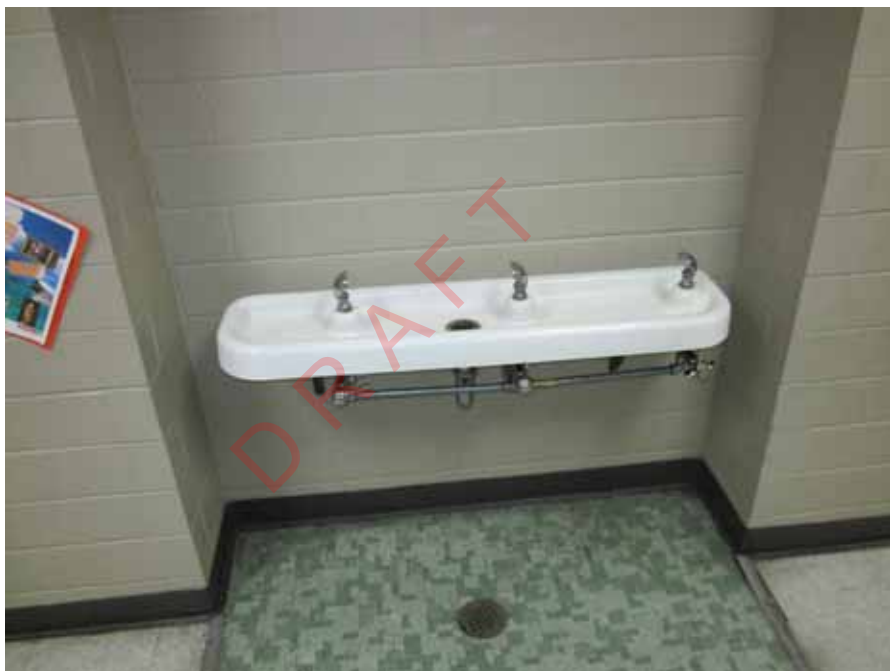
PHOTO PNES4 - DRINKING FOUNTAINS

- The drinking fountains at this campus do not meet current ADA standards. (Refer to Photo PNES4)
- There is inadequate parking and drives at this campus. Parent pick-up/drop-off and Bus pick-up/drop-off are in the same area. This creates traffic issues and safety concerns.

It is recommended the campus be brought up to current accessibility code standards.

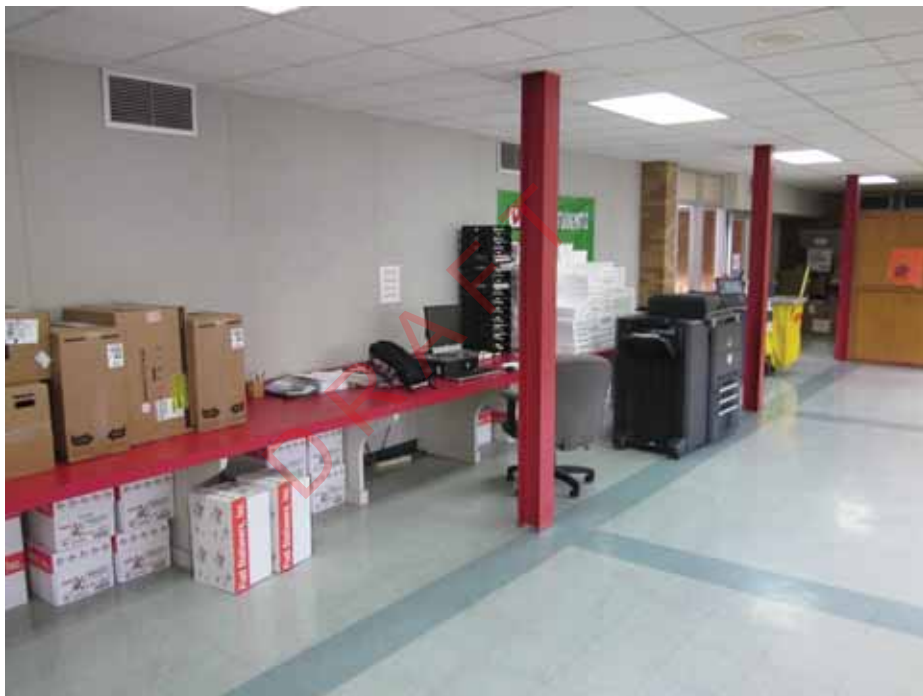
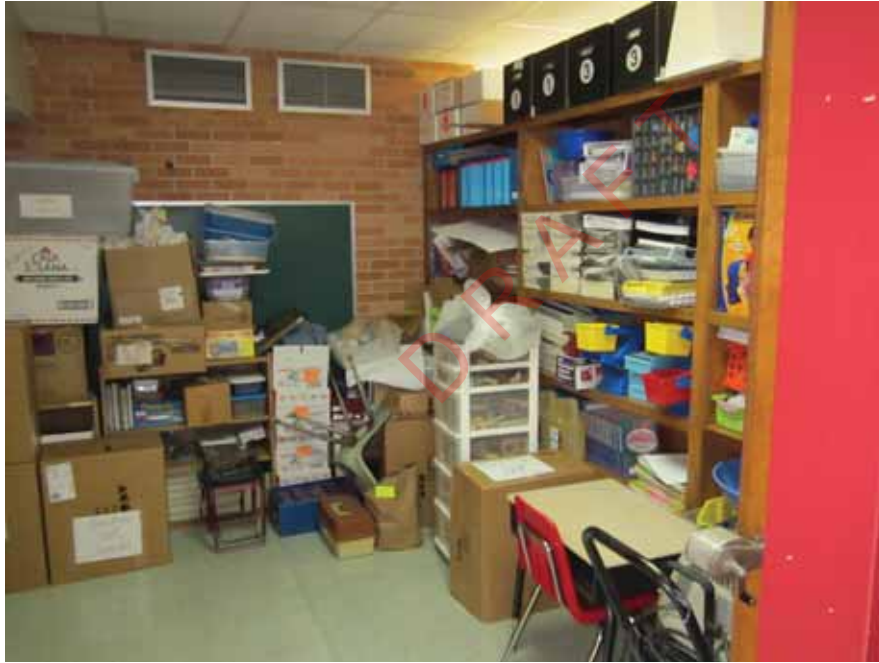
- There is inadequate storage and teacher workroom space at this campus. Corridors space is currently used as workspace for teachers. (Refer to Photo WES2 and WES3)

PHOTO WES2 - TEACHER WORK AREA

PHOTO WES3 - STORAGE

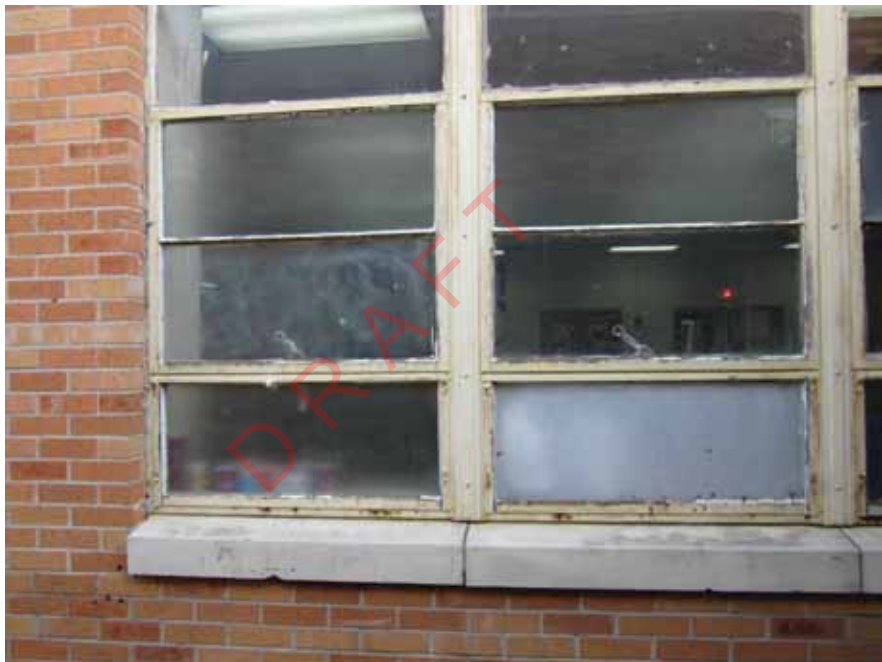
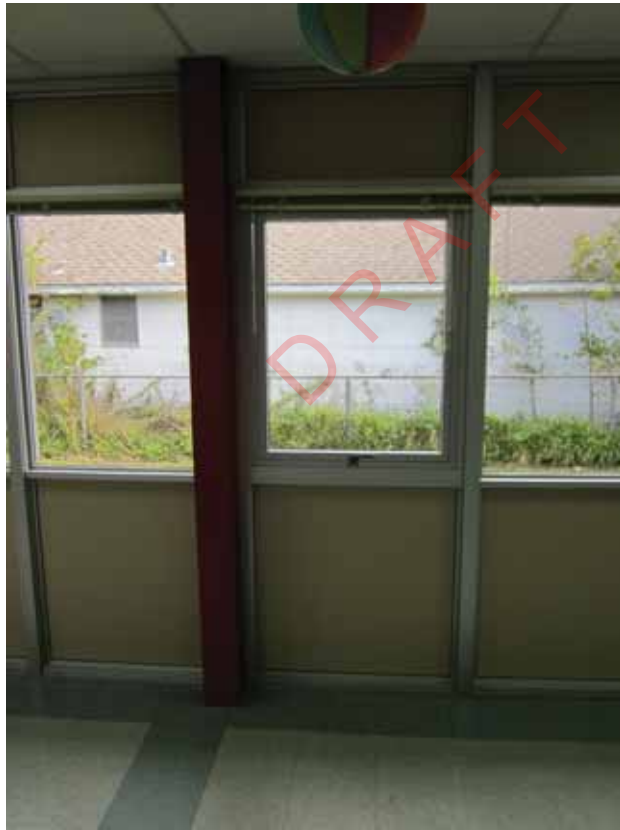
- The 3rd grade classrooms at this campus are of adequate size to meet current TEA Facilities Standards requirements for size.
- Some of the original steel windows are existing. In other locations, where the original windows have been replaced, the replacement windows are single pane glass and non-insulated metal panels. (Refer to Photos WES4 and WES5)

PHOTO WES4 - WINDOWS

PHOTO WES5 - WINDOWS
